# Field Service TECH TIP NEWS

**RI-0012**

**IM-5006**

**TICKING NOISE CORRECTION**

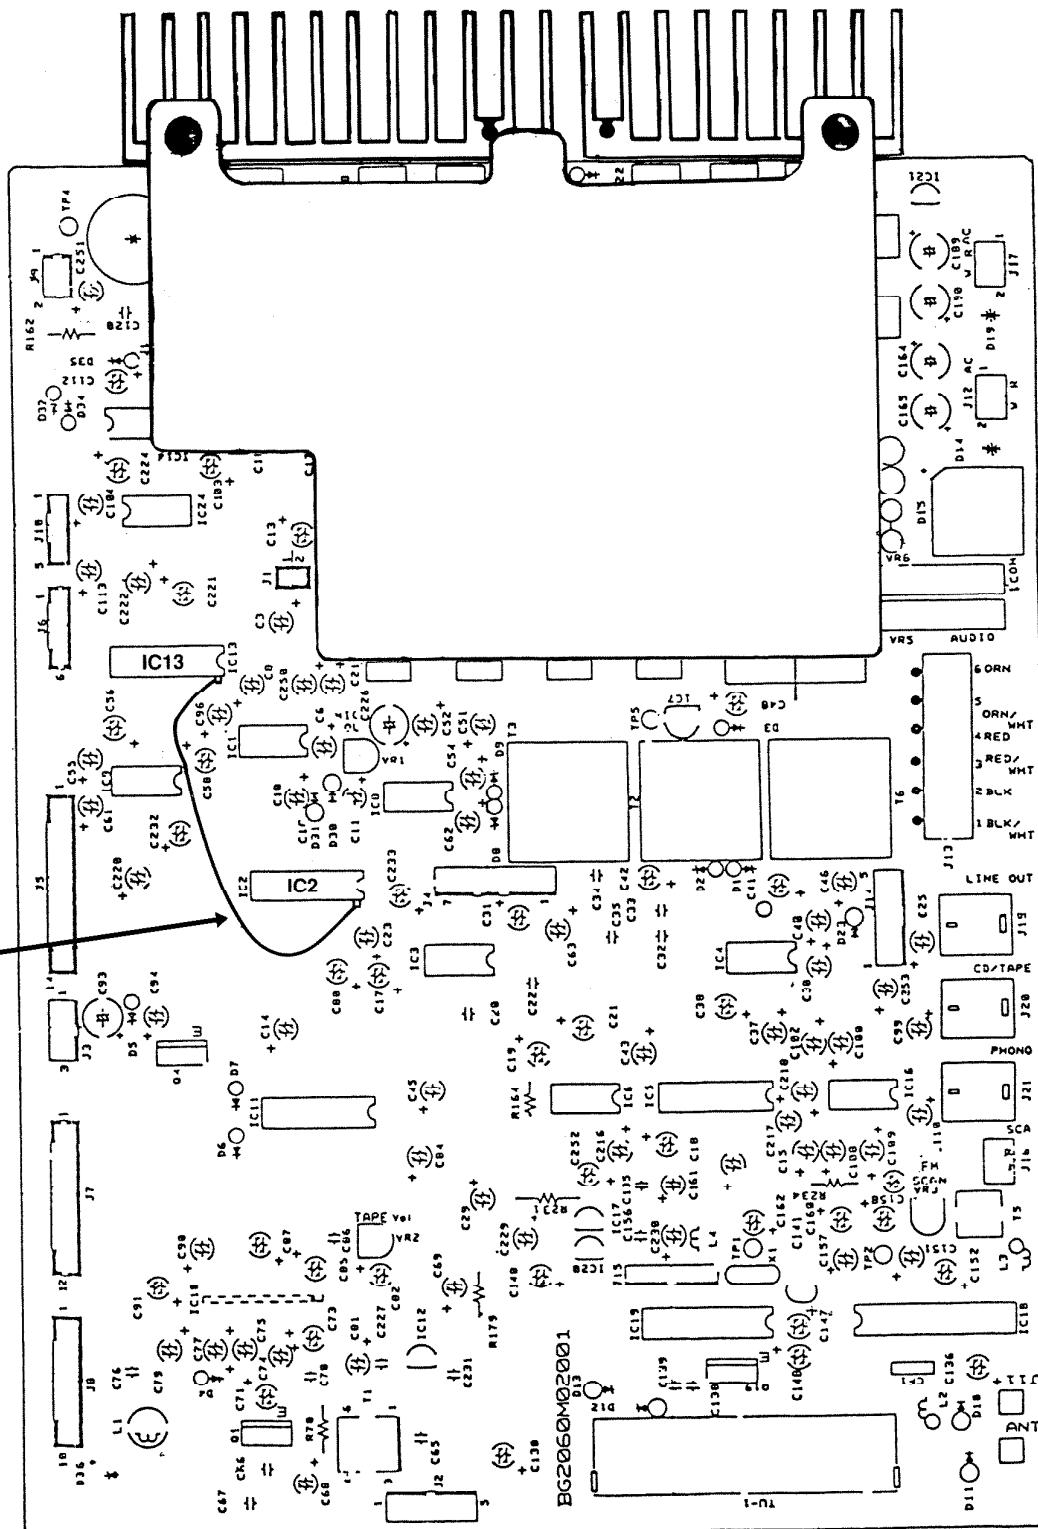
## MAIN PC BOARD

**PURPOSE:** In several instances there have been reports of a ticking sound coming from the master station. The tick is at one second intervals. This modification will correct this rare occurrence.

1. Disconnect main power from system by turning off main breaker or disconnect low voltage AC supply wires from transformers.
2. Locate Main PCB on right side of master station.
3. Locate IC2 and IC13 on main PCB (Figure 1).
4. Apply a small amount of solder to the tip of the soldering iron. Then touch the tip to Pin 14 of IC2. Allow the solder to flow from the iron's tip onto Pin 14. Repeat for Pin 14 of IC13.
5. Cut a 5 inch piece of 22 AGW wire and strip each end back about 1/4 inch.
6. Using needle nose pliers, hold the wire next to Pin 14 of IC2 and reflow the solder on Pin 14. Make sure no solder bridges or shorts have been formed to any other pins. Repeat for Pin 14 of IC13.

**CONNECT WIRE  
BETWEEN —  
PIN 14, IC2 AND  
PIN 14, IC13**
